## **STUDENT SUMMER INTERNSHIP TECHNICAL REPORT**

# **Analysis of Tank Chemistry Compliance with Chemistry Specification in Double-Shell Tanks**

### **DOE-FIU SCIENCE & TECHNOLOGY WORKFORCE DEVELOPMENT PROGRAM**

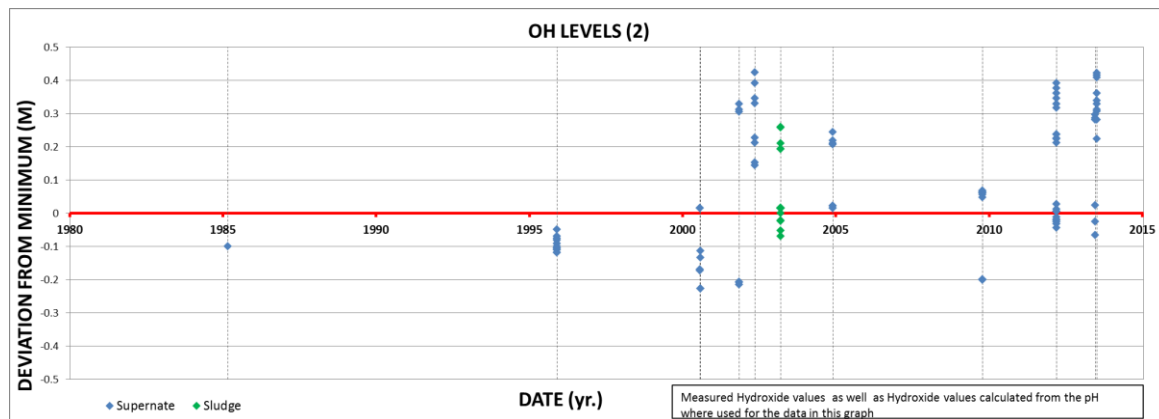
Figure 10. Hydroxide levels in Tank AN-102.

Therefore, the graphs plotting the hydroxide levels over time do not look the same as they did for the tanks on the AY-farm. In order to make the graphs as easy to read and as accurate as possible, the y-axis was changed to read the deviation from the minimum hydroxide which was calculated in an extra row in the specification calculator (Figure 10).

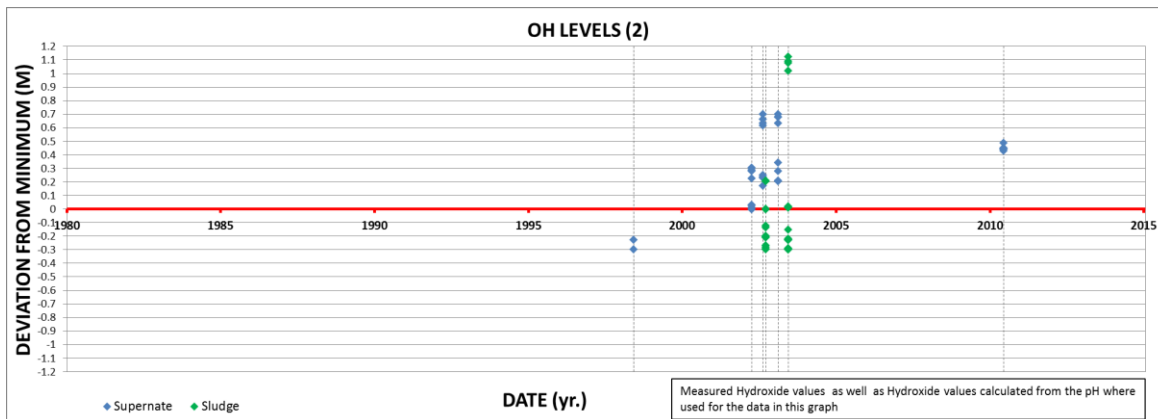
Figure 12. Hydroxide levels in Tank AN-107.

Like tank AN-102, AN-107 has waste with higher nitrate concentrations, requiring the same type of graph (Figure 12).
