# DOE-FIU SCIENCE & TECHNOLOGY WORKFORCE DEVELOPMENT PROGRAM

## STUDENT SUMMER INTERNSHIP TECHNICAL REPORT

# Electrical Upgrades for Hanford Supporting Facilities

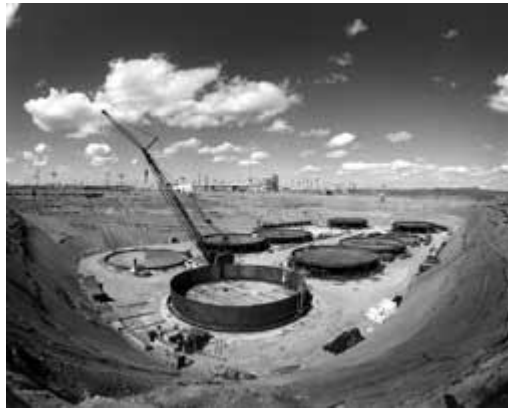
**Figure 1. Initial construction of Hanford tanks.**

In 1943, as part of the Manhattan Project, the U.S. government built the Hanford Site. It eventually included nine nuclear reactors as well as various supporting and processing facilities. The reactors, as well as the other facilities, were used to produce plutonium, which was used for the manufacturing of atomic weapons for WWII as well as the cold war. The reactors at Hanford produced plutonium from 1944-1987. The many years of plutonium production produced a huge amount of radioactive waste which was stored in various underground tanks. Today, there are about 53 million gallons of waste at the Hanford Site and the Department of Energy is working to contain and dispose of this waste in an environmentally safe way. Facilities have been put in place to monitor and dispose of the waste as well as address other issues onsite. Some of these facilities are aging and are in need of upgrades in order to ensure their continued safe operation. Figure 1 shows the initial construction of the Hanford tanks while Figure 2 shows the completed reactors in full operation.

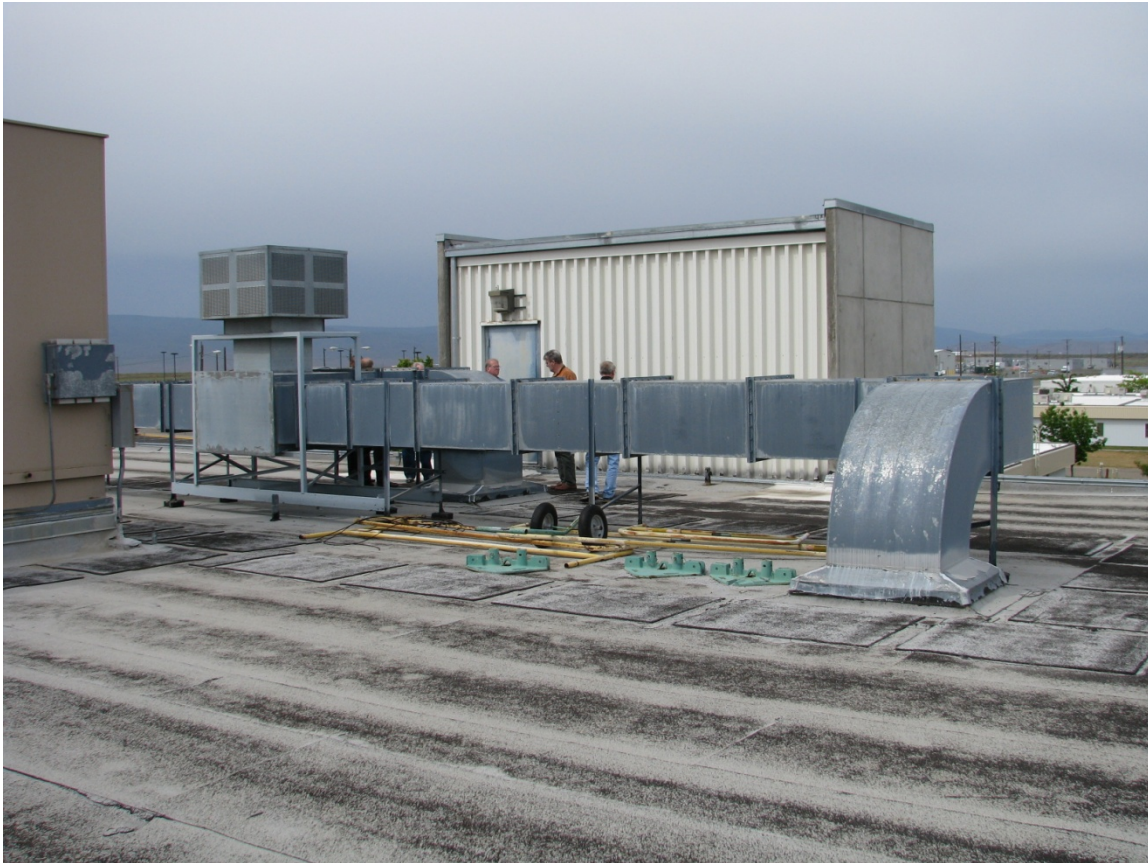
**Figure 3. Existing HVAC unit on 2750E Building.**

For my internship, I was assigned to the In-House Engineering Group under the management of John Huber and the mentorship of Rob Gurnick. Throughout the summer, I assisted with various electrical tasks that were assigned to this group. These included an upgrade to the HVAC unit on the 2750E building. Figure 3 shows the existing HVAC unit.

For this task, I completed field activities such as taking measurements of the dimensions of the various ducts as well as locations of conduits. I also reviewed old drawings and schematics of the building in order to determine the wire allocations. I contacted the manufacturers of the various components in order to determine exact specifications and power draws for the electrical power draw calculations. These were then used in order to determine what panel would be used to supply power to the various components and to determine the necessary breakers for circuit protection. I was further assigned the tasks of constructing mounts for the various enclosures and designing the conduits to run the wiring. Figure 4 shows the design for the control mounts for the HVAC unit and Figure 5 shows the cut-off switch.

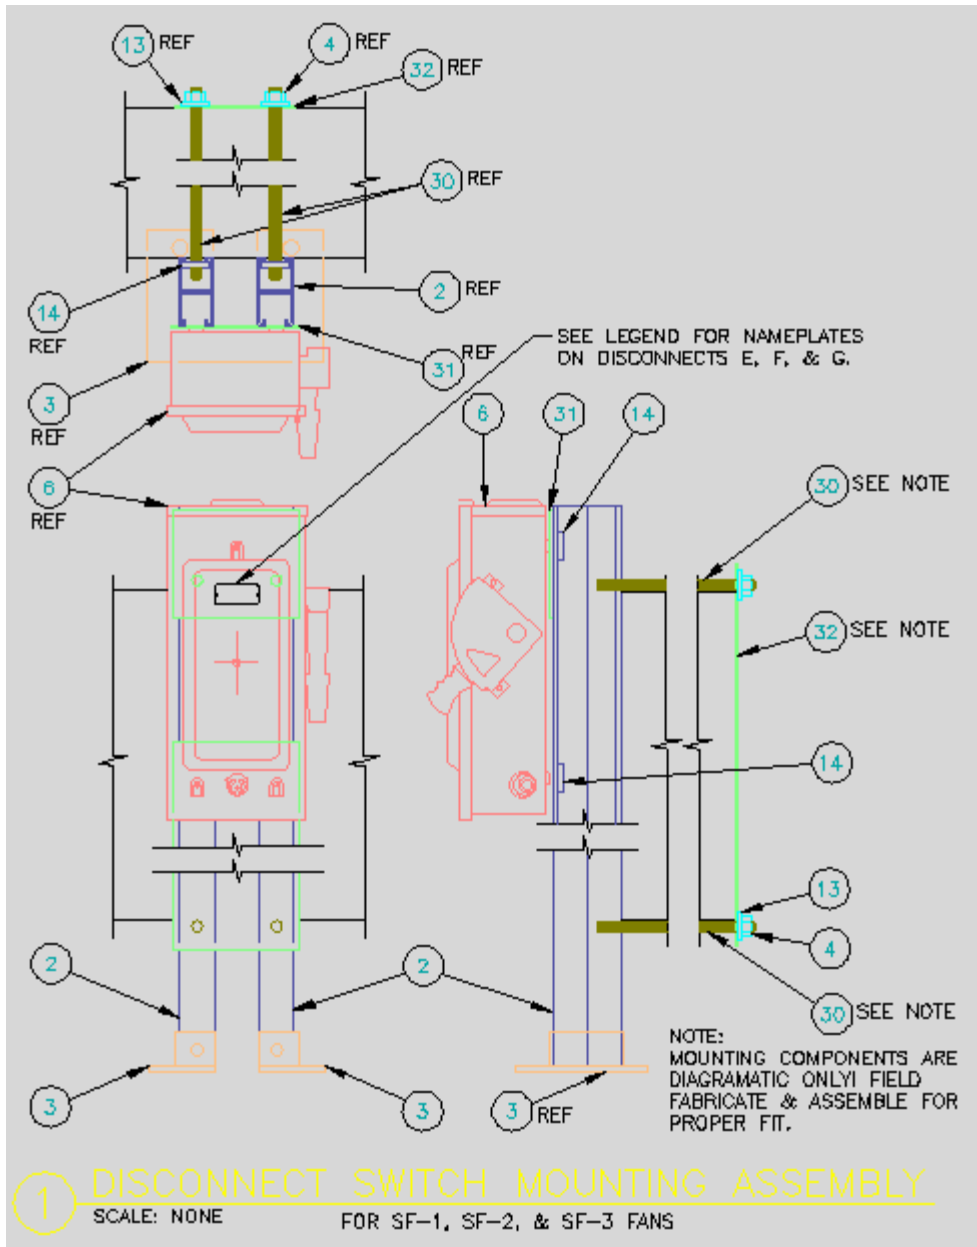
**Figure 5. Cut-off switch for HVAC unit.**

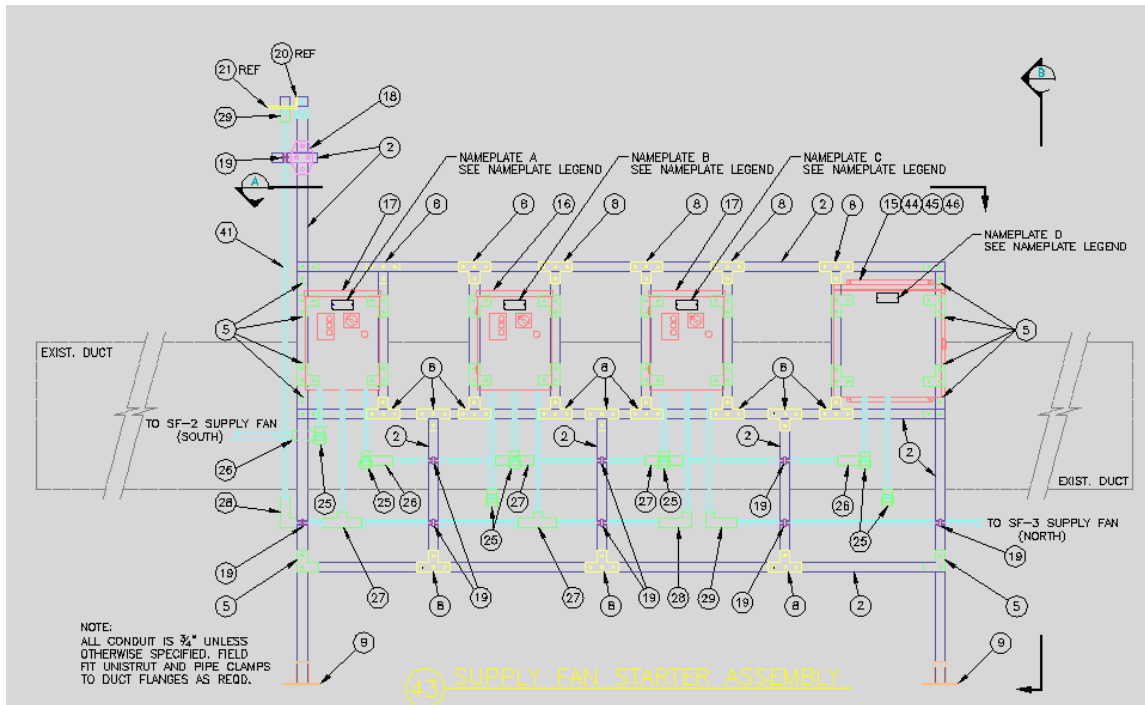
**Figure 6. Design for conduit routing on HVAC unit.**

There were certain constraints on the conduit type as well as the enclosures because they were going to be mounted on the roof of the building where they would be exposed to the elements. Figure 6 shows the design for the conduit routing and Table 1 provides the parts list for the HVAC upgrade.

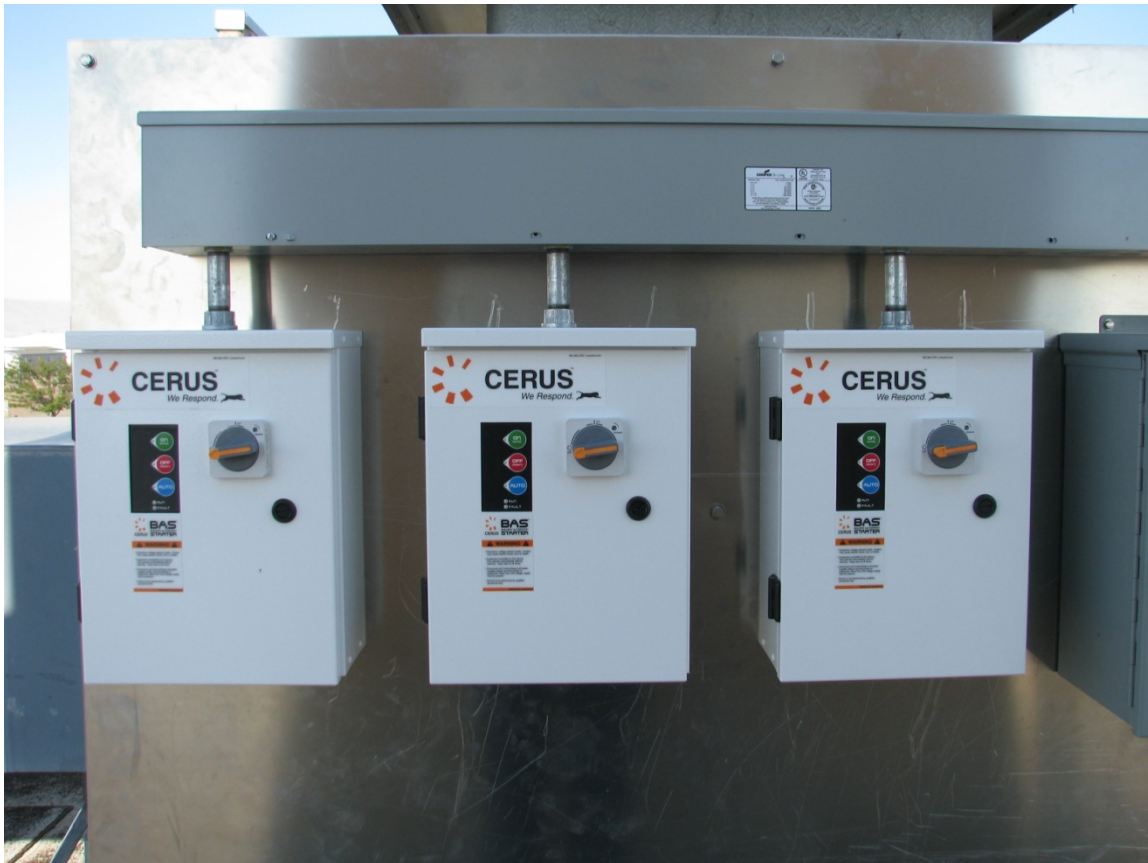
**Figure 11. Control enclosures after being assembled.**

The conclusion of all this summer's work is the completion of upgrades to the facilities based on the engineering designs produced. With all the engineering change notices approved and completed, they were then sent to the field workers who implemented the changes based on the designs and using the materials ordered from the parts lists. The upgrades to the different facilities were implemented in a safe and timely manner. Figures 11, 12 and 13 show the completed control enclosures and upgraded electrical panel.

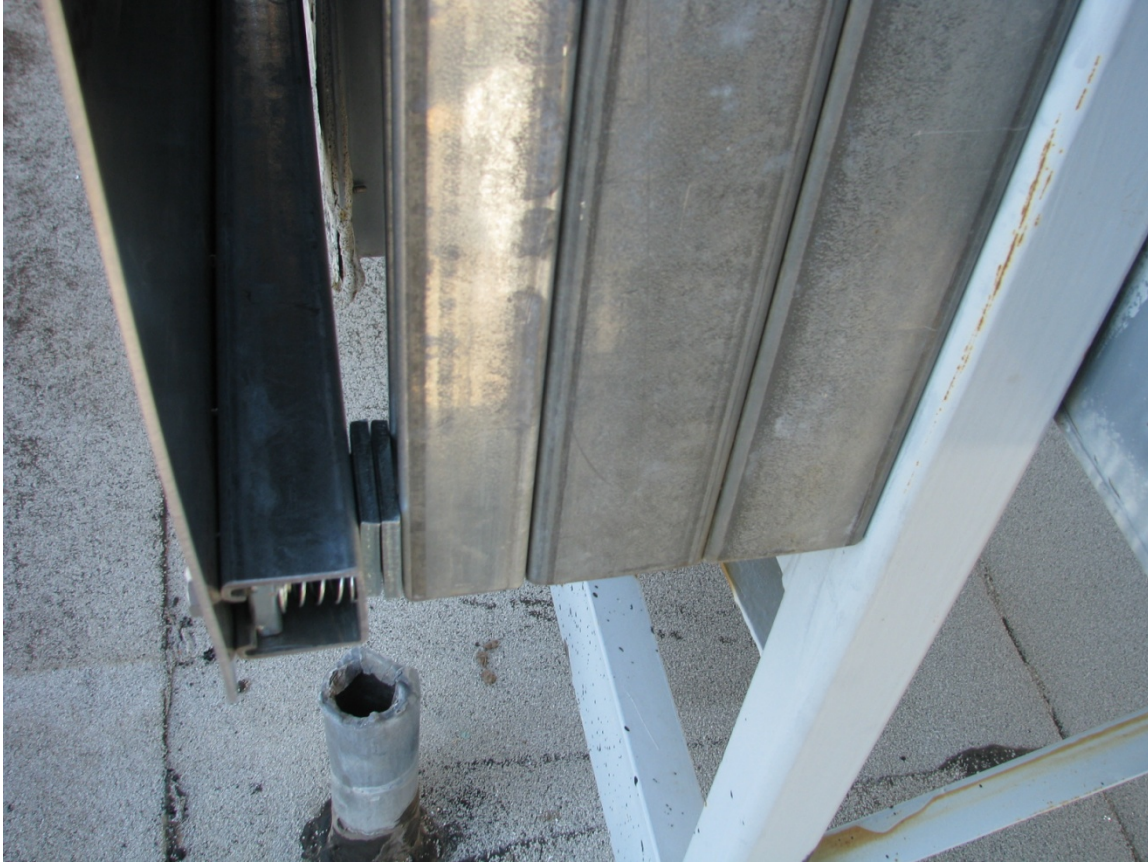
**Figure 12. Side view of control enclosures.**

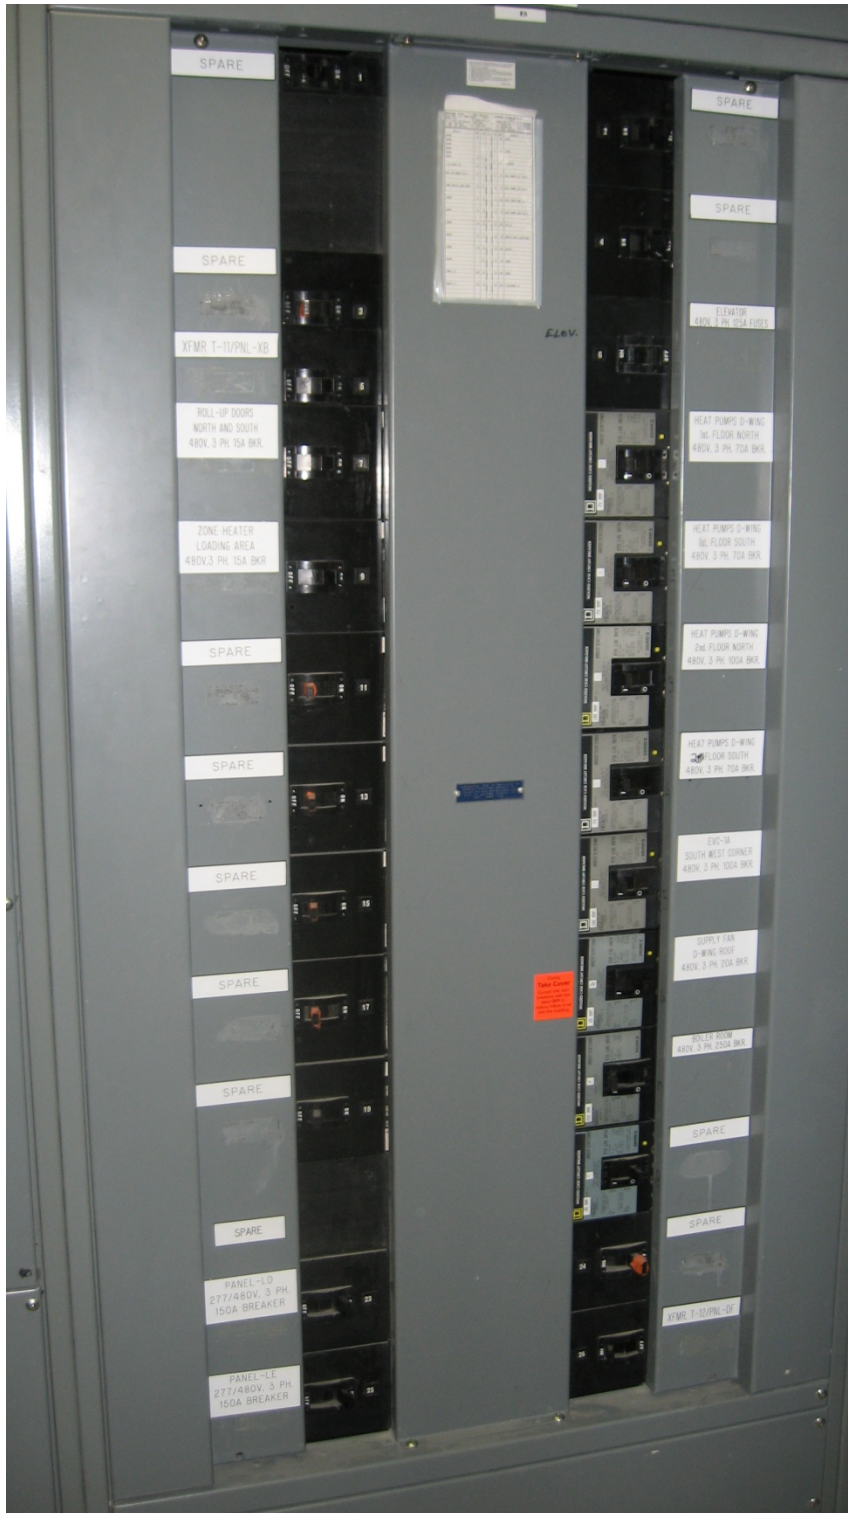
Figure 13. Electrical panel for upgrade.
