Energy Facility Contractors Group - Lessons Learned and Best Practices

Open Air Demolition of Asbestos Gunitite by Using Track Mounted Wet Cutting Saw

Explosive Demolition of Buildings 337, 337B and the 309 Stack

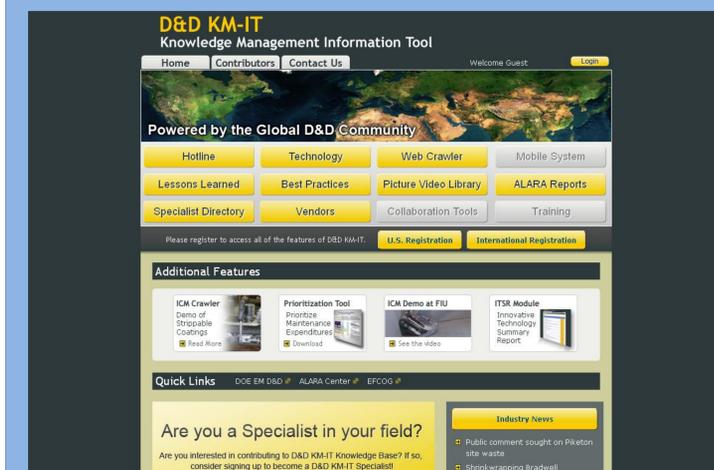
Two of the modules are the Lessons Learned and Best Practices. Once the Lessons Learned or Best Practice document is routed through the process, as shown to the left, the document is posted on the D&D KM-It for the D&D Community to access for their use.
