STUDENT SUMMER INTERNSHIP TECHNICAL REPORT

Navigation and Positioning Tests for Vector Platform

DOE-FIU SCIENCE & TECHNOLOGY WORKFORCE DEVELOPMENT PROGRAM

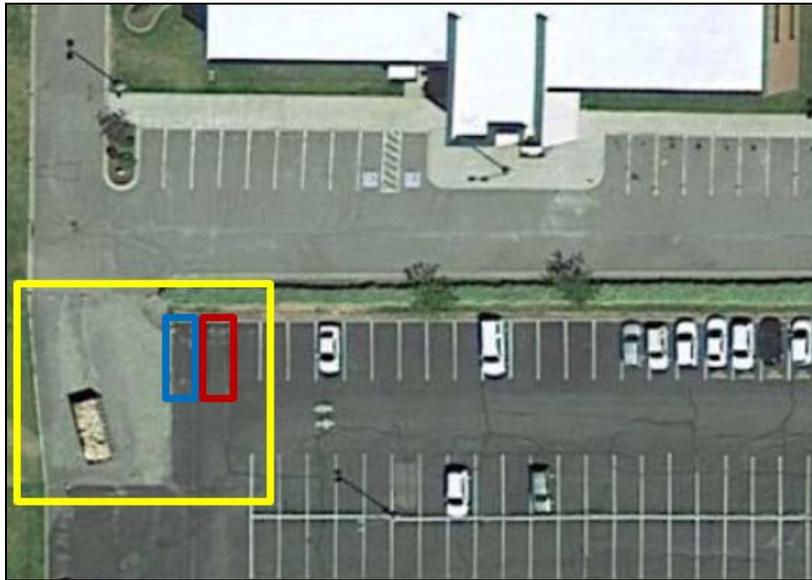
Figure 1: Overhead image of test location

All test sessions took place on a small gravel patch located on the south side of the 2505 Garlick building, outlined in yellow in Figure 1 below. This small patch of gravel is used as a connection between two adjacent parking lots and as a spot for a dumpster which made it made it mostly

The precautions and considerations taken during test sessions at this location included enhancing robot visibility using a tall safety flag to alert transient traffic, as well as the setup of a small pop-up sunshade and safety materials used for environmental protection for workers. Additional considerations were made in where vehicles could be parked and equipment could be placed, outlined in red and blue respectively in Figure 1.

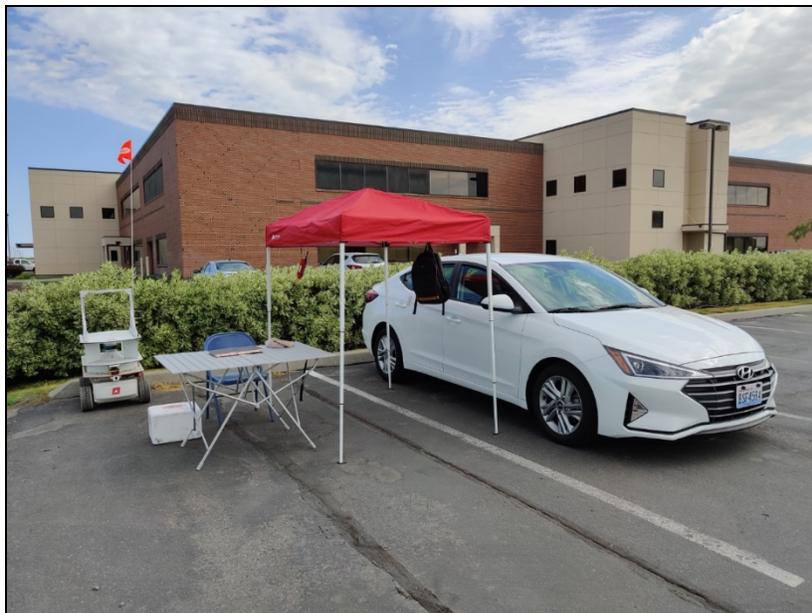
Figure 2: Example of equipment setup

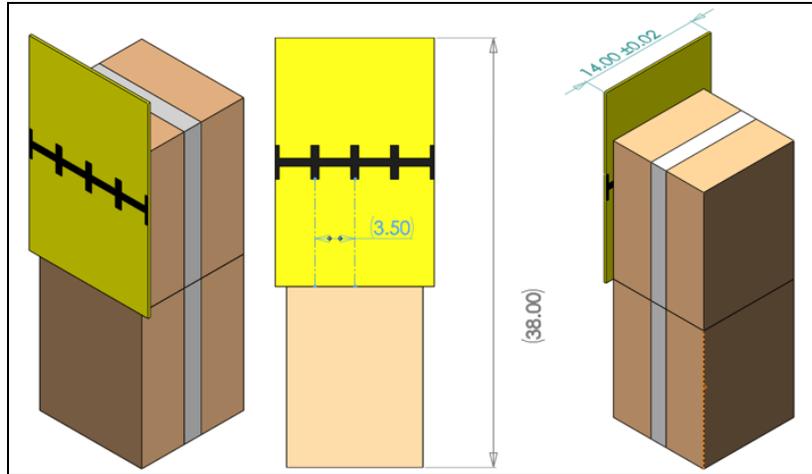
Figure 3: Model of visual aid

To ensure validity and quality of the observations and results gathered during a test session, standardized visual aids were used. The visual aids were meant to be uniform targets to be captured by the onboard camera at each capture point and served as orientation references for determining the final orientation of the Vector. A model of a visual aid used during testing is shown in Figure 3.

The visual aids each featured a poster board with uniform markings spaced out equally along the width of the board. By placing the visual aid either in the center or the edge of the image frame (an example of which is shown in Figure 4), the captured images could be compared to a control set of images – the first set of images in each test cycle. During the test sessions, the live feed revealed the offset of the robot from its stopping orientation, which was then validated during post-processing of the images.

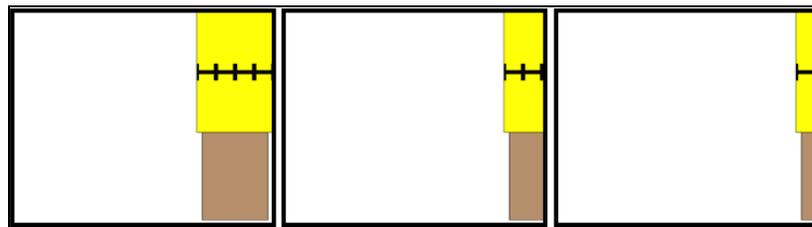
Figure 4: Mock image frames, from left to right: too far left, centered, too far right

For the test sessions conducted, the visual aids provided a clear indication of whether the Waypoint Vector was pointed correctly at the target or not, as well as provided an external reference that highlighted how the Vector was arriving at the target location. As an example, for most instances observed during testing, the Vector would stop in the same position each time, but the visual aid was not necessarily centered within the image frame when it came to a stop. This was useful in differentiating the overall navigation capability of the Vector (i.e. just driving from one point to another) versus the positioning capability of the Vector (i.e. being pointed in a specific direction at each point).

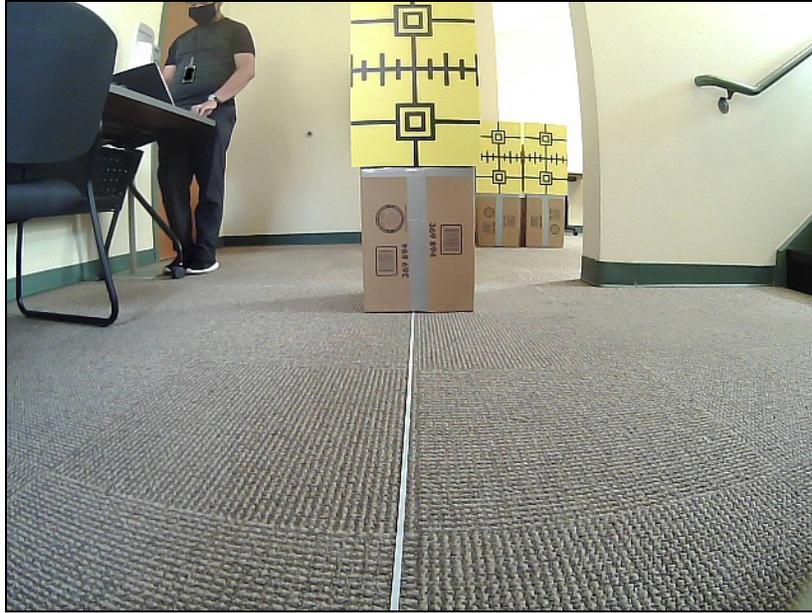
Figure 5: Visual aid at 4 feet away from onboard camera

The visual aids were targeted at least approximately four feet from the onboard camera at the capture points during setup. This was to ensure that most of the measurement board is captured by the camera and that the markers could be clearly seen within the captured images. Additionally, if the platform moved closer to the visual aid than anticipated, the markers on the board were still visible within the image. Sample images of the visual aid are presented in Figures 5-7.

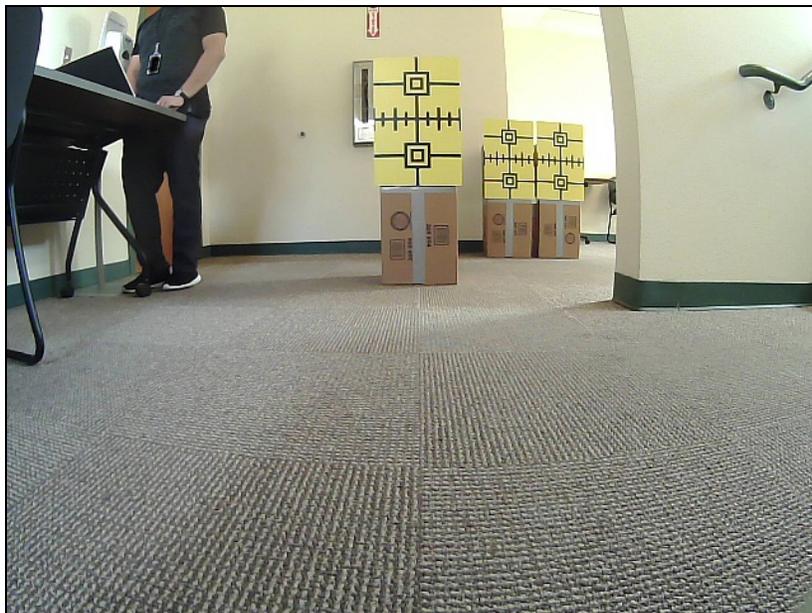
Figure 6: Visual aid at 6 feet away from onboard camera

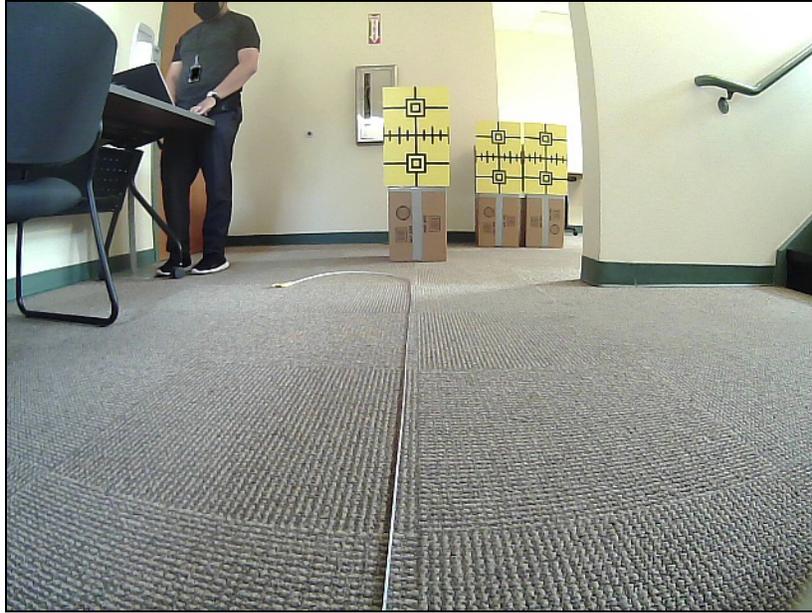
Figure 7: Visual aid at 8 feet away from onboard camera

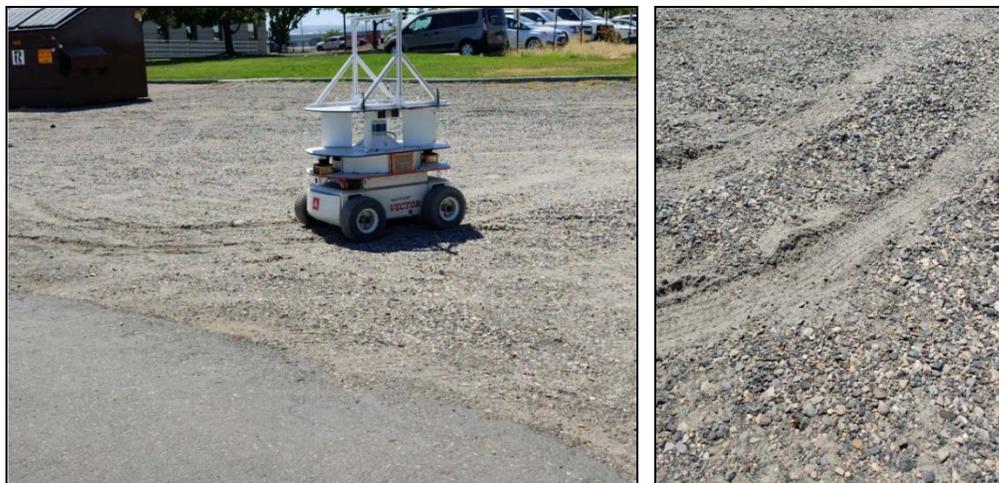
Figure 8: Vector on a pre-test cycle and tracks left in the gravel by solid tires

To observe the overall path planning of the Waypoint Vector, tracks left by the solid tires in the gravel were visually inspected and documented. To illustrate this, Figure 8 depicts the observable path imprint in the gravel caused by the Vector traversing the same location repeatedly over time. The Vector was documented to be consistent in path planning if the tracks in the gravel aligned well, while varied tracks in the gravel represented behavioral changes in path planning from point-to-point. A gravel rake was used to smooth over the imprints at the capture points after each test cycle.

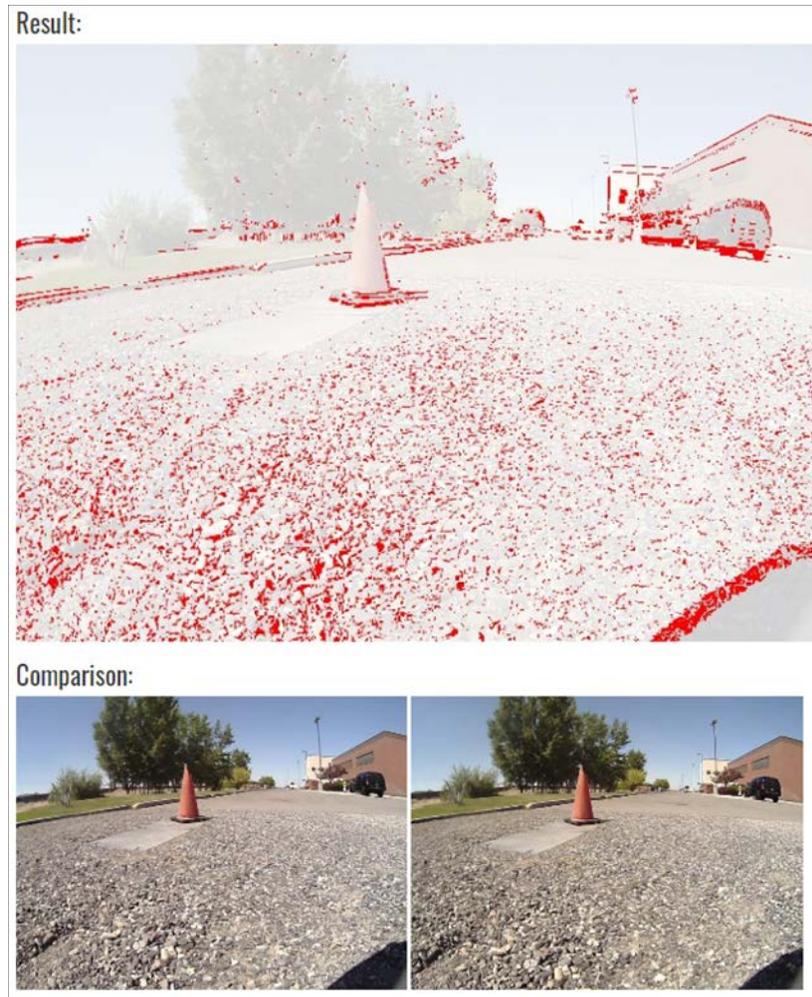
Figure 9: Comparison of two similar images from pre-testing

Utilizing image processing software – such as the OnlineImageDiff¹ comparison tool based on the ImageMagick[®] image processing suite – an assessment to the overall quality of the observations were made from the testing sessions. An example of an image comparison through the software can be viewed in Figure 9.

The notable aspects of utilizing image processing software to compare two images is observed by looking at the lower two images being compared in Figure 9. Through visual comparison alone, it is difficult to tell the difference between the two images. During the test sessions, these two images pass off as acceptable positioning of the robot. However, the accuracy of that

The top image in Figure 9 is an example of the software analysis of the lower two images. All the red dots represent anomalies the software picked up between the first and second image passed through. As presented in Figure 9, the images are different – albeit slightly – from each other. From these results we can determine the acceptable range of difference between two captured images – mid-cycle image and start-of-cycle image for example – and qualify the Vector’s precision in navigation. This image processing method is the most straightforward way to ensure quality of the results gathered throughout the test sessions.

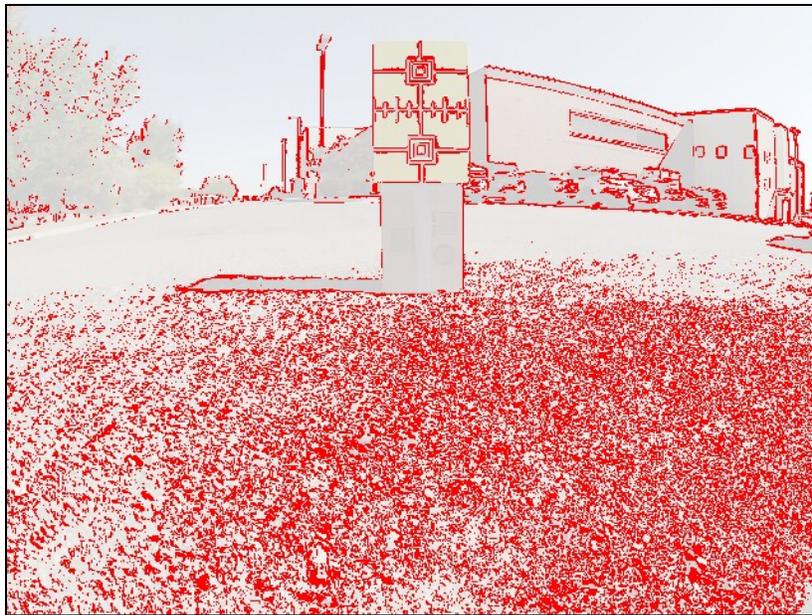
Figure 10: Example of an aligned image

There are differences to be noted between how the three types of images presented in the table were assessed. For an image to be considered aligned, the resulting image comparison exhibited a near-match in the position of the visual aid within the image frame. An example of this would be when the comparison revealed that the visual aid markers aligned on top of each other. This is illustrated in Figure 10. Well aligned images were not a rare occurrence within the total results and represent the Vector's navigation and positioning capabilities under ideal circumstances.

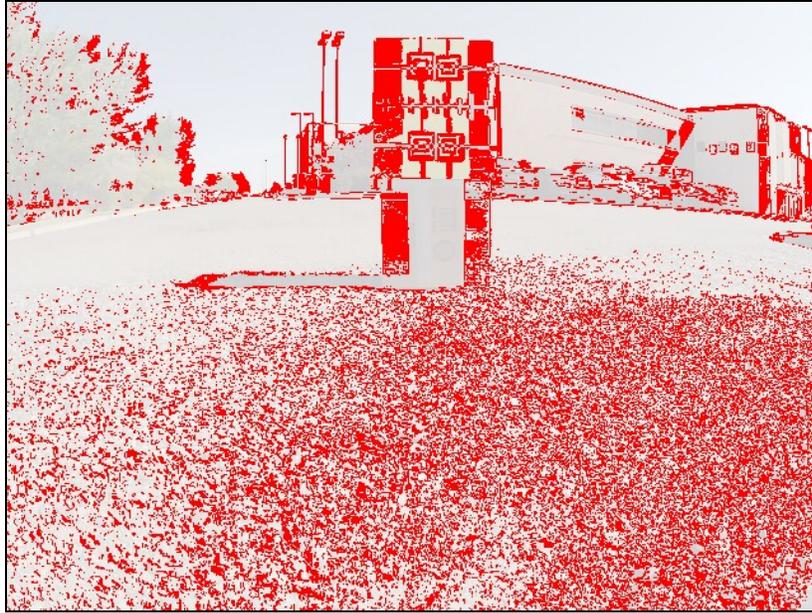
Figure 11: Example of an in-tolerance image

An in-tolerance image represents cases where the resulting image comparison exhibited at most a two-marker variance observed from the uniform markings on the visual aid. For example, an image is in-tolerance if the comparison revealed that the visual aid shifted two markers to the right in a mid-cycle image, which is illustrated in Figure 11. In-tolerance images represent the bulk of the images gathered from the Vector's onboard camera and provide insight into the normal operation of the Vector.

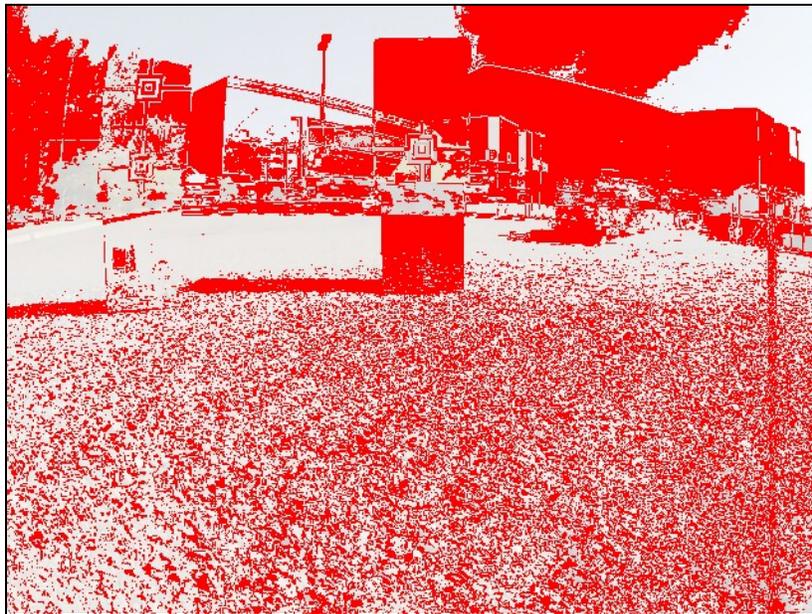
Figure 12: Example of a missed image

A missed image is represented by a case where the visual aid was out of tolerance within the image frame – more than two markers right or left of the control image – or where the Vector captured an image that did not match at all, as illustrated in Figure 12. Missed images are the types of images that are preferably avoided. However, these images can be a result of external factors such as transient traffic and the maintenance status of the Vector.

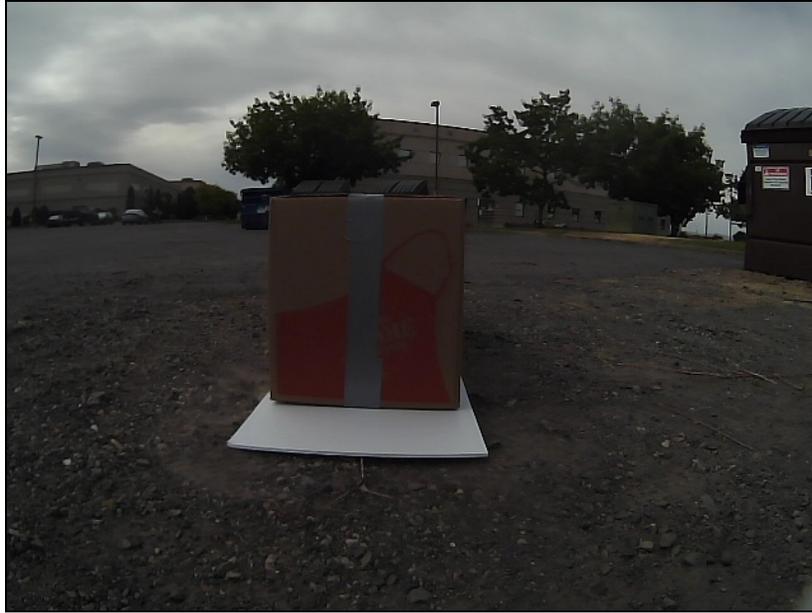
Figure 13: Visual aid knocked over by wind during testing

The low numbers can reflect more than simply the Vector's orientation capability. Outside influences also affected some – but not all – of the images. Vehicles driving and parking near stopping points and the Vector itself impacted some of the captured images. During some test sessions, high winds were present that knocked down and shifted the visual aids from their positions and impacted some of the test images, such as in Figure 13. There are also considerations to be made when looking more closely at how the Vector behaved when transition points were in use versus how it performed when transition points were not in use.

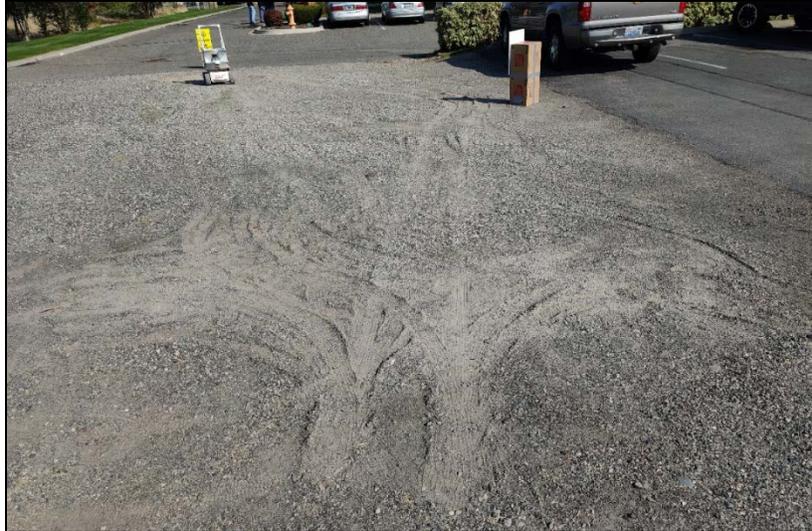
Figure 14: Path planning variance evidenced by tire imprints in gravel

The second observation made regarding path planning involved the impact of the use of transition points as part of the Vector's test routine. Without transition points, the path planning widely varies, likely due to the freedom the lack of transition points provided to choose paths to navigate around or near objects. An example of this is illustrated by Figure 14. On the other hand, using transition points assisted the Vector in consistently planning a path from one capture point to the next. This is likely due to the segmentation of the path into two sections, which makes its behavior more predictable, illustrated by Figure 15.

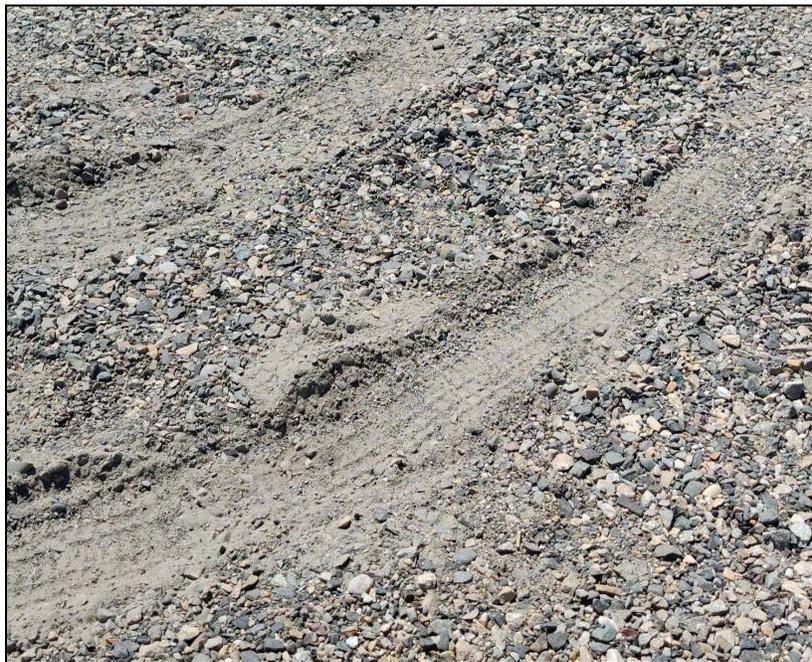
Figure 15: Path planning consistency evidenced by tire imprints in gravel
