# STUDENT SUMMER INTERNSHIP TECHNICAL REPORT

## 2D Dam-Break Analysis of L Lake and PAR Pond Dams Using HEC-RAS

DOE-FIU SCIENCE & TECHNOLOGY  
WORKFORCE DEVELOPMENT PROGRAM

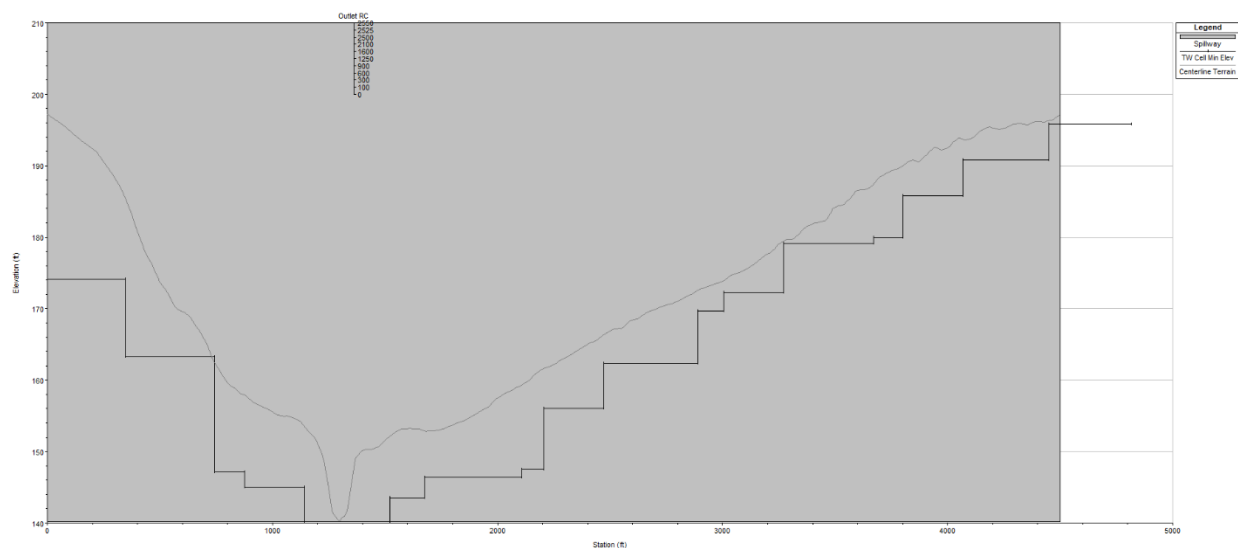
**Figure 4: Cross Section of PAR Pond Dam**

The dams are input as storage area/2D area connections using simplified dam geometric data (Table 7). In the connection data editor, only the dam's cross-section is displayed (Figure 3, Figure 4). The Steel Creek Dam at L Lake has 6 ft diameter conduit with an upper and lower sluice gate. PAR Pond Dam consists of a weir connected to an 8x8 ft channel. Both outlets were modeled with a pool elevation vs discharge curve (Table 5, Table 6). The Steel Creek Dam sluice gates were assumed to be fully open in all cases.
